Report on the investigation into the capsizing
of
JBB RONG CHANG 8, IMO No. 8783529
at Muar, Malaysia
on
21 March 2018

Report of Casualty Investigation

Capsize of Sand Dredger

“JBB RONG CHANG 8”

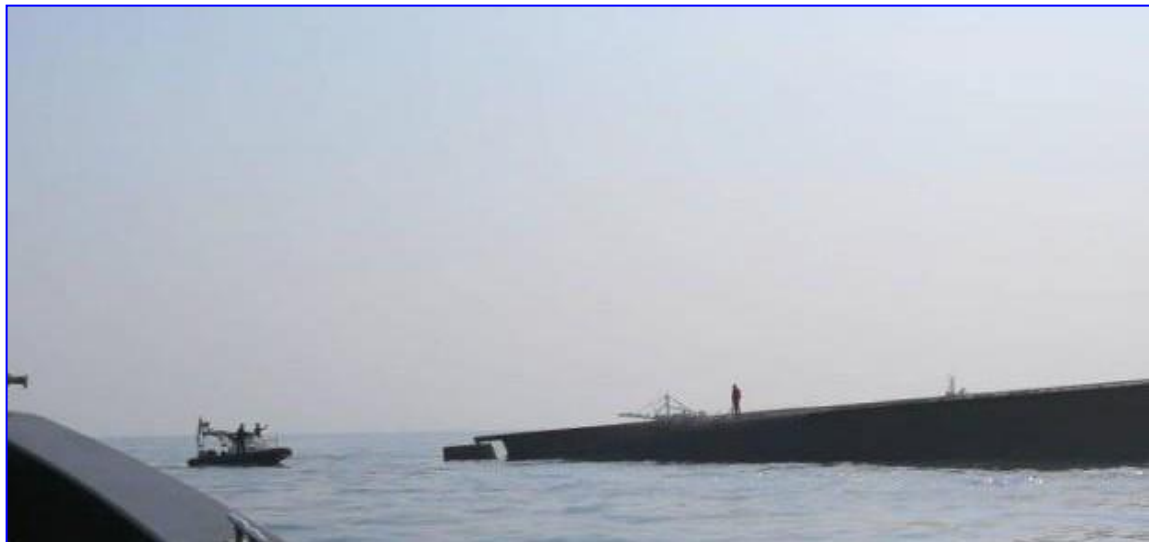
Photo of Capsized JBB Rong Chang 8 (rescuer standing on her flat bottom) – Star Online

3. MV JBB Rong Chang 8 (JRC8) overturned in the waters off Parit Jawa in position latitude 1°5.9'N, longitude 103°30.9'E, off Muar, Malaysia on 21 March 2018, Wednesday, morning.
4. The Malaysian Maritime Enforcement Agency's Batu Pahat base received the distress call at 0850 hours in that morning. The Chinese owned Commonwealth of Dominica-registered vessel had a total of 9 crew and 9 dredging staff, comprising one Malaysian, one Indonesian and 16 Chinese. After the casualty and the sea and rescue operation 5 survivors were rescued, 5 deceased and 8 are still missing.
5. Oil boom was laid around the vessel to contain the fuel oil that was gradually escaping from the vessel.

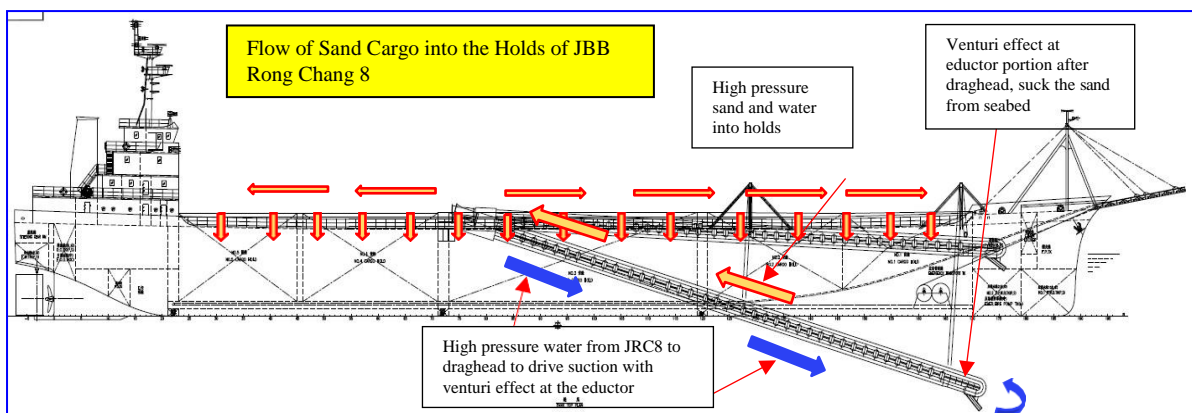
- Events involving hazardous material –
 - The job of the JRC8 was to dredge and transport sand from the seabed in the sand resource areas to the reclamation areas. Sand was “dredged” by suction effect created by the venturi system in the pipe section when a high velocity flow of water runs. Sand was therefore “sucked” from beneath the seabed to the cargo holds of the JRC8 by an extremely high velocity flow of seawater. The sand was then “threw” from the pipe end, into the holds of the JRC8 via a “common rail” pipeline running from aft to forward above the holds of the ship, along with the water creating a slurry cargo of sea sand in the hopper of cargo holds of the JRC8.

- The sand which is in a slurry form especially with the water on top of the sand pile became hazardous as it could literally “flow” uncontrollably. Cargo shift and Free Surface Effects were inadvertently created.

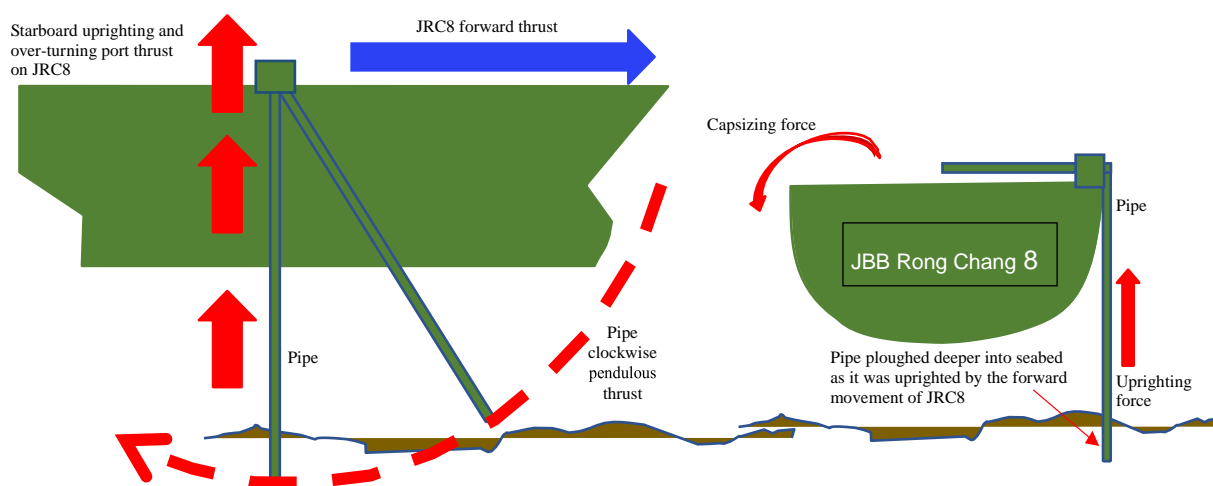
- i. After the wires parted, the JRC8 took a sudden and greater heel to port because of the “push” exerted by the pipe (the usual working angle at the joint onboard the JRC8 of the pipe leading into the seabed was about 70° lead forward) on the pipe joint at the starboard side of the main deck (the suction and water pipes arrangement was at the starboard side of JRC8).
- ii. The pipe was supposed to lead 70° forward during normal dredging operation. When the wires were broken, the 200 tonnes pipe was being dragged over the seabed by the moving JRC8 such that the pipe dug deeper into the seabed and came to an upright position singlely-crutching the starboard side of the JRC8 higher than when the pipe was at about 70° during normal dredging operation.

- iii. This sudden port heel caused the slurry sand in the full holds to shift correspondingly to the port of the JRC8 thereby causing her port deck to be awashed and righting arm of her stability vanished altogether. The JRC8 therefore capsized on her portside at location.
- iv. The lifting wires were reported to have been renewed in September 2017 (refer to the attachment). The certificate of inspection of the wire rope verifies that the breaking strength is 1104 KN which according to calculation meet the requirement of such load, which in this case is the entire pipe system using such wire falls.

- a) Design and maintenance of the wirefalls for the suction pipe of such dredgers should be done_ in accordance with the rules of lifting appliances such as cargo cranes and derricks.
