FINAL REPORT

**SINKING OF
SUPPLY VESSEL
OCEAN COOPER 2
IN THE SINGAPORE STRAIT
ON 14 FEBRUARY 2019**

MIB/MAI/CAS.061

**Transport Safety Investigation Bureau
Ministry of Transport
Singapore**

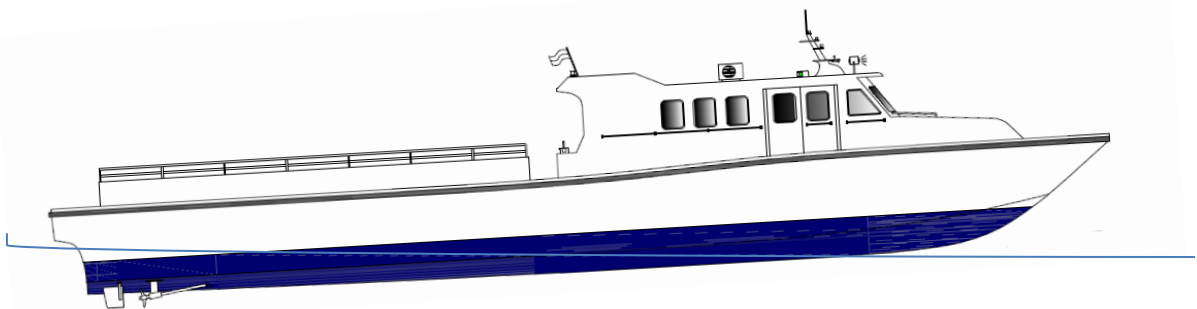
- 1.1.1 In the late hours of 13 February, 2019, OC2 departed Singapore⁸ with 16 pallets (evenly distributed over the cargo deck), to be delivered to the Polaris Melody (PM). With a tentative estimated time of arrival (ETA) of 0300H on 14 February 2019 to the rendezvous location⁹, OC2 navigated with an approximate speed of 7 knots¹⁰. At this speed, according to the skipper¹¹, the stern of OC2 would be between 0.5m to 0.7m above the waterline (illustrated in **Figure 1**).

Figure 1: An illustration of OC2's position relative to the waterline (blue) with 16 pallets at the speed of about 7 knots – *not to scale*

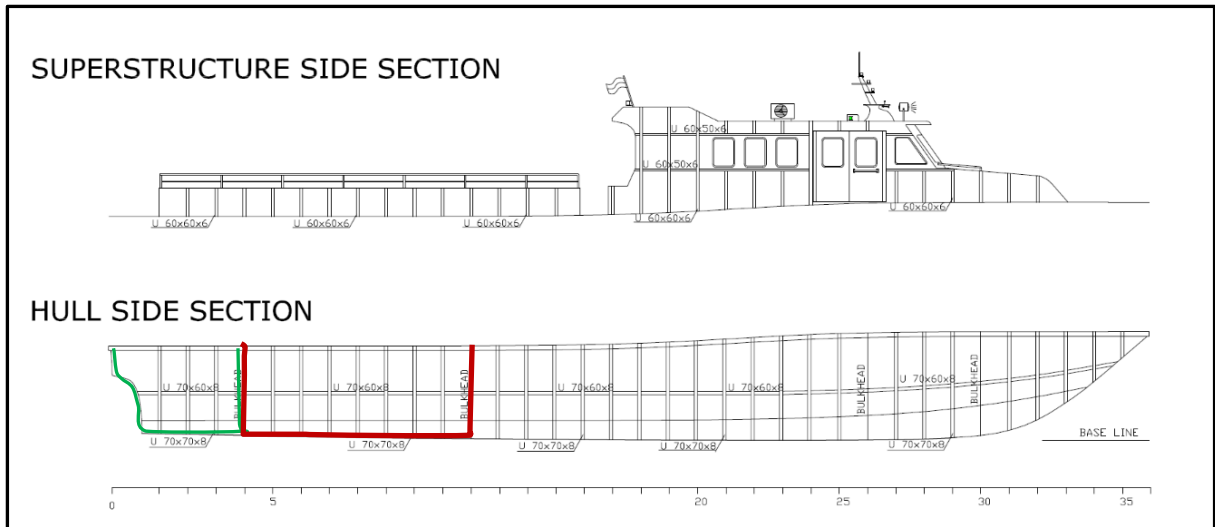
- 1.1.5 The skipper instructed the engineer to check and to also start the bilge pump¹⁴ for the engine room compartment¹⁵. The engineer first went out of the superstructure to open the manhole cover (flushed with the main deck) for the steering gear compartment (see **Figure 2** – annotated in green), and observed that steering gear compartment had a breach, and that sea water had completely filled up the space.

Figure 2: OC2's layout with Fr. numbers marked on the scale at the bottom

- 1.1.6 On inspecting the engine room compartment (annotated in red in **Figure 2**) which was separated by a watertight bulkhead from the steering gear compartment, the engineer observed that sea water was entering the space from the starboard corner through the exhaust fan¹⁶ (see **Figure 3**). OC2 had 36 frames (Fr.). The steering gear compartment¹⁷ was from Fr. 0 to Fr. 4 and the engine room compartment was from Fr. 4 to Fr. 12

5.1.1 To implement a process of checking the compartments below the waterline at a regular basis for early detection and intervention on vessels under its operation. **[TSIB-RM-2020-006]**

5.2.1 To implement a process of checking the compartments below the waterline at a regular basis for early detection and intervention. **[TSIB-RM-2020-009]**

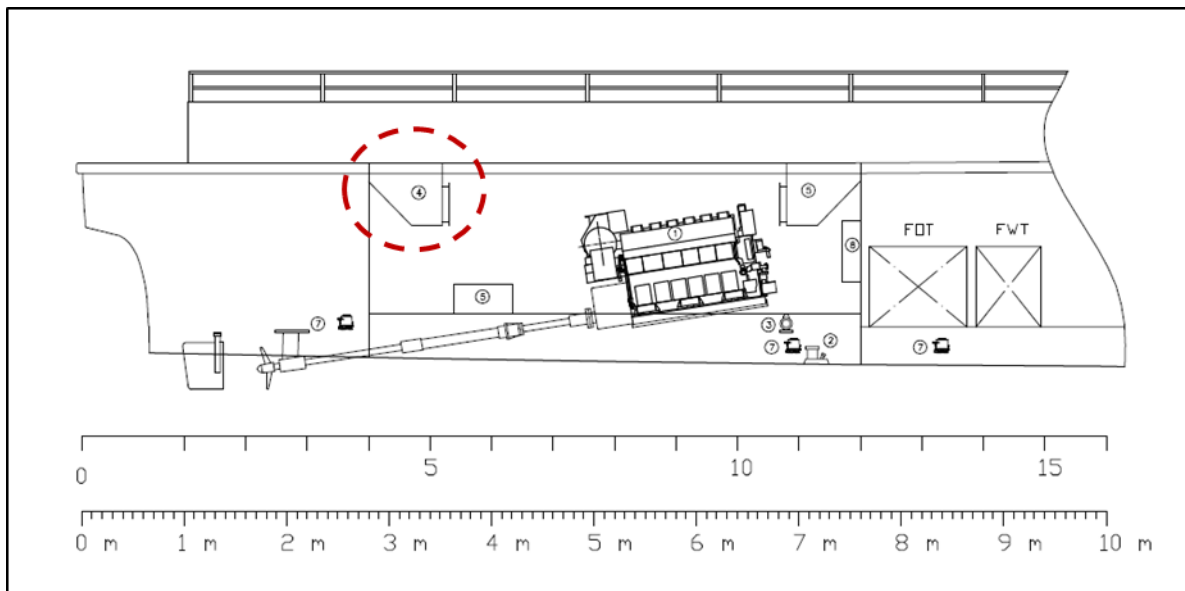
Figure 3: Starboard side view of engine room layout. Exhaust fan is circled in red.

- 3.2 The consequent increase in OC2's aft draught caused sea water to enter the engine room compartment from the two exhaust fan openings which were flushed with the main deck. By the time the crew noticed the problem, the water ingress was much more than the bilge pumps could have handled, despite the crew of OC2 using a portable pump from Jolly Rachel, and eventually resulted in the crew abandoning the vessel.

2.3.3 Though the exhaust fans were flushed with the main deck and situated under the wooden dunnage to maximise cargo space, considering the possibility of a flooded compartment causing the stern to sink closer to the waterline, additional risk mitigating measures should be considered for such vessels, to prevent an ingress of water into the engine room compartment.

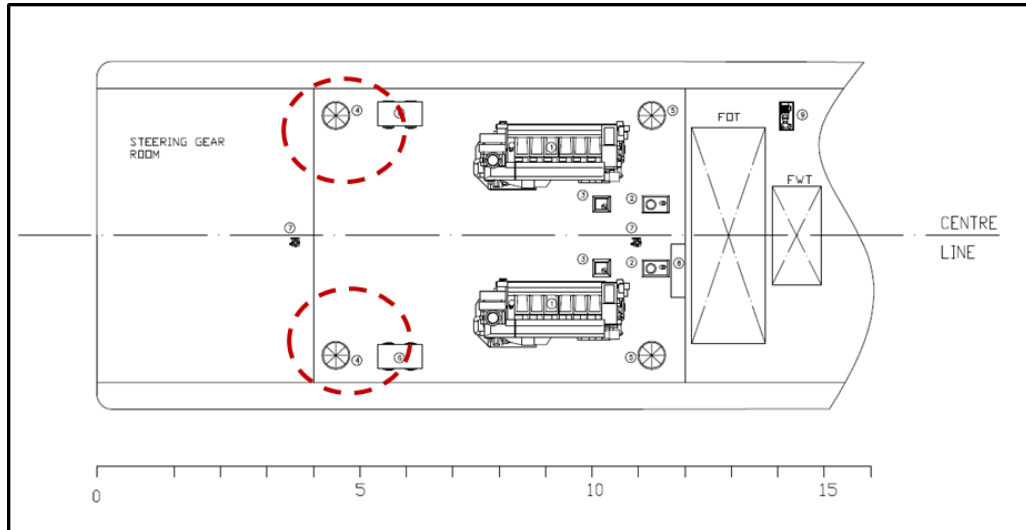
1.1.7 The exhaust fan outlet was flushed with the cargo deck as per the general arrangement plan. Photographs provided by the flag Administration indicated that the outlet(s) were covered by wooden dunnage (typically used to protect cargo). See **Figures 4a and 4b**.

Figure 4a: Plan view of engine room compartment layout. Exhaust fans are circled in red.

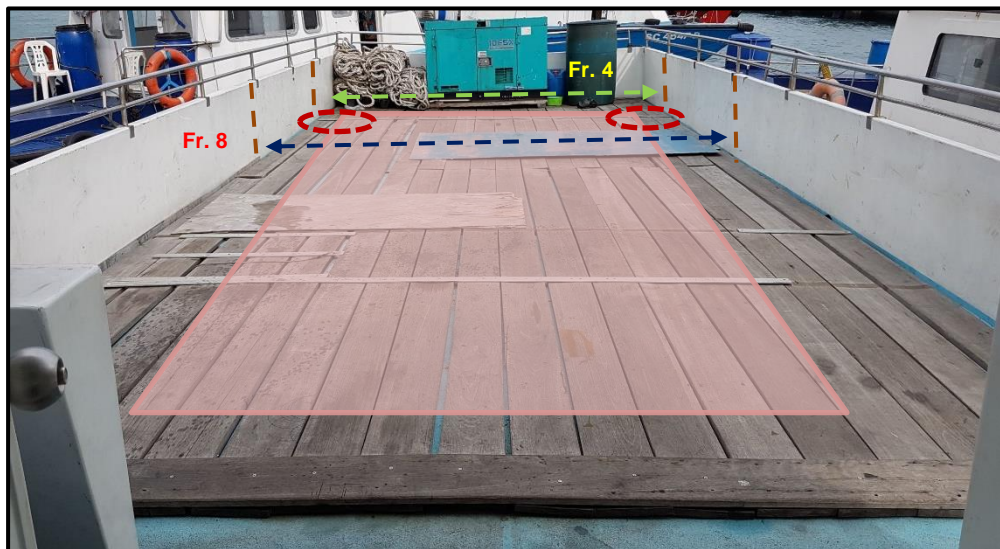
Figure 4b: Photograph taken looking aft towards the cargo deck (annotated by TSIB with approximate cargo which extended across the cargo deck till the aft– *not to scale*). Location of exhaust fans are circled in red. Cargo was evenly distributed till Fr. 4

1.1.8 Green dashed line in **Figure 4b** indicates the approximate location of the watertight bulkhead separating the steering gear compartment and engine room compartment (at Fr. 4) below the cargo deck.

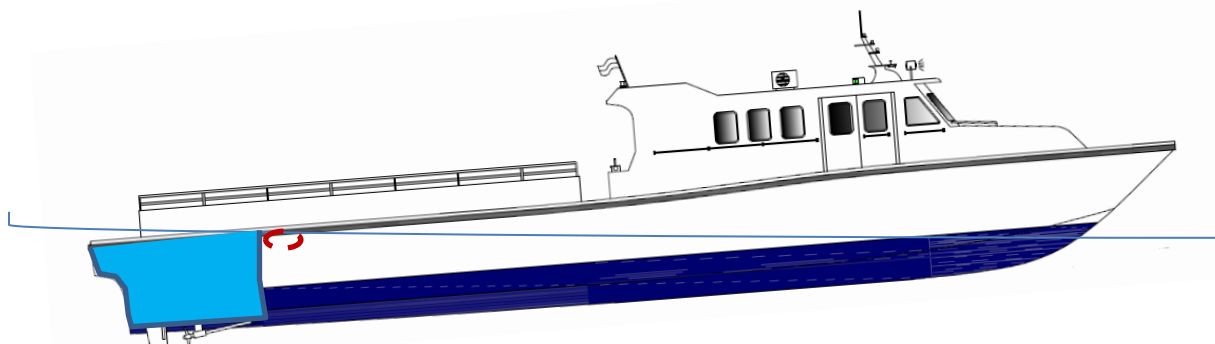
Figure 6 – Illustration of the stern's position according to the skipper – *not to scale*

- 2.1.4 The reasons for the breach of the steering gear compartment of OC2 (indicated by blue in the figure above) could not be established during the period of OC2's departure from Harbourfront Centre and its location while waiting for PM to arrive.
- 2.1.5 With an estimated volume of 17 cu.m, the steering gear compartment would possibly contain an added weight of at least 15T²⁷ which would have further reduced the freeboard²⁸. It is likely that by this time, sea water would have likely made its way nearer to the location where the exhaust fans were situated (under the dunnage) and entered the engine room compartment, eventually disabling the vessel and causing it to sink.
