Report on the investigation into the capsizing
of
JBB RONG CHANG 8, IMO No. 8783529
at Muar, Malaysia
on
21 March 2018

Report of Casualty Investigation

Capsize of Sand Dredger

“JBB RONG CHANG 8”

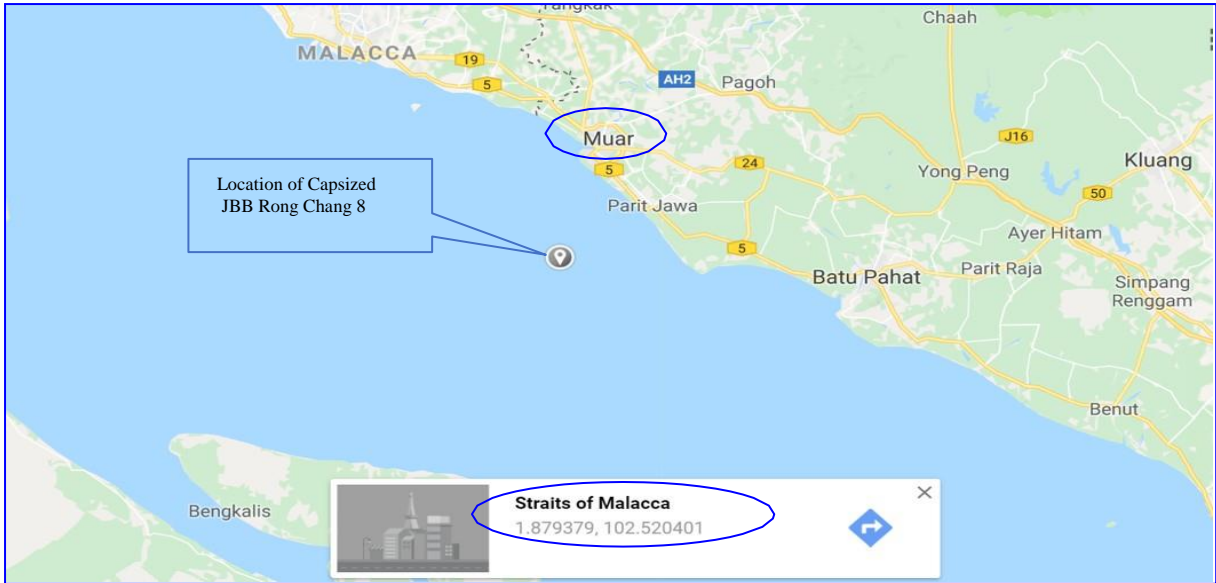
Photo of Capsized JBB Rong Chang 8 (rescuer standing on her flat bottom) – Star Online

3. MV JBB Rong Chang 8 (JRC8) overturned in the waters off Parit Jawa in position latitude 1°5.9'N, longitude 103°30.9'E, off Muar, Malaysia on 21 March 2018, Wednesday, morning.
4. The Malaysian Maritime Enforcement Agency's Batu Pahat base received the distress call at 0850 hours in that morning. The Chinese owned Commonwealth of Dominica-registered vessel had a total of 9 crew and 9 dredging staff, comprising one Malaysian, one Indonesian and 16 Chinese. After the casualty and the sea and rescue operation 5 survivors were rescued, 5 deceased and 8 are still missing.
5. Oil boom was laid around the vessel to contain the fuel oil that was gradually escaping from the vessel.
